Controls and quality demands in the jewellery investment casting process

M. Actis Grande, D. Ugues, S. Bezzone, D. Pezzini

Memoria presentata al Convegno:
Cera persa e investment casting: innovazione arte e tecnologia,
Alessandria, 9 ottobre 2003

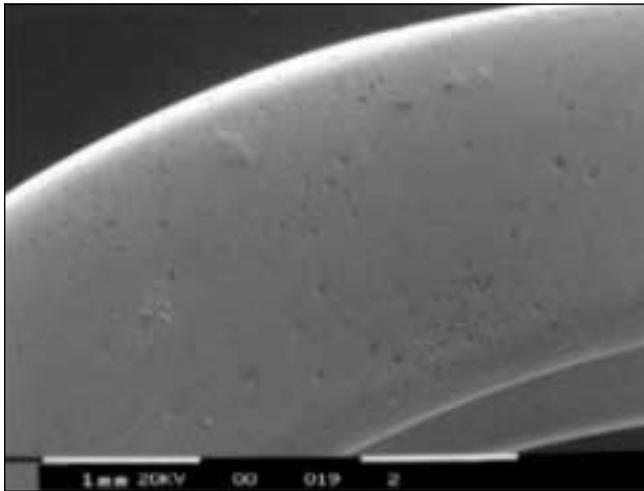
Figure 1 shows the surface of an object with evident defects. A more detailed analysis, carried out in different areas of the

Figure 1: SEM image of a defective object at the final stage of production

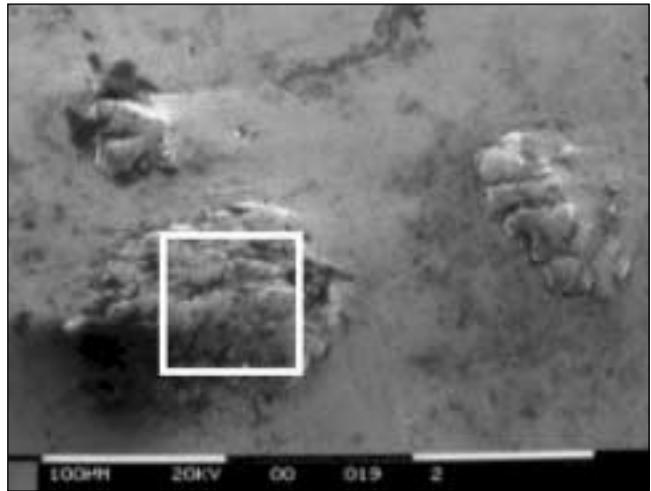
Figure 3: Detail of defective area

The EDS analysis, performed in the marked areas, put into evidence the presence of osmium (Fig. 2) and iridium (Fig. 3), which are not reported to be present in the base alloy preparation phase. Their presence is therefore to be lead to the refining step of the starting pure gold.

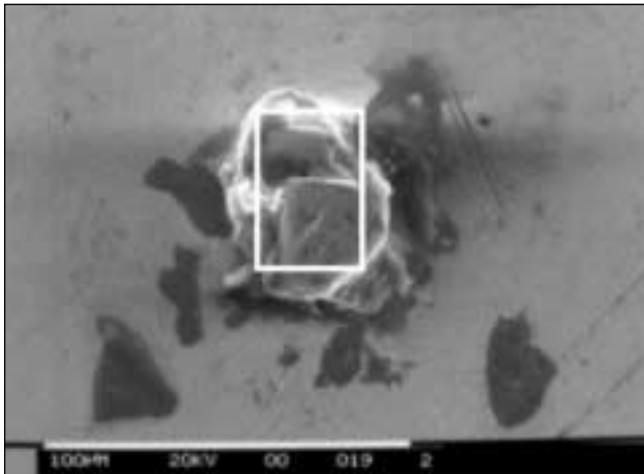
Figure 2: Detail of defective area

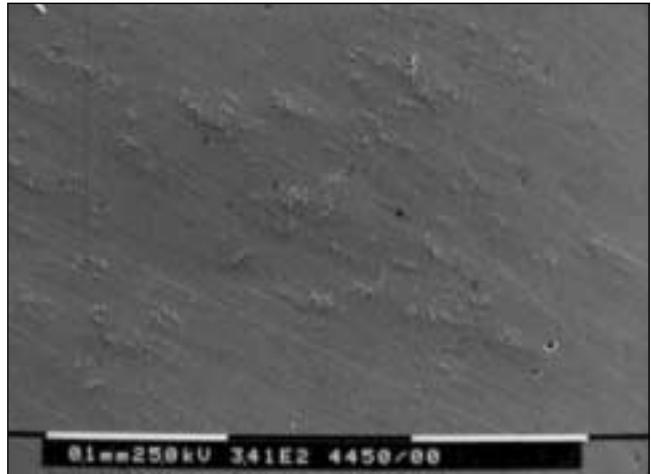
Figure 4: Defects observed at SEM at low magnification

Microstructures reported in Figures 4 and 5 show some defects deriving from the presence of iridium, in this case used as grain refiner in the production process.

In this case, some segregated areas rich in Ir are observed. It can be supposed that the origin of the defect is due to an improper mixing during the preparation of the alloy.

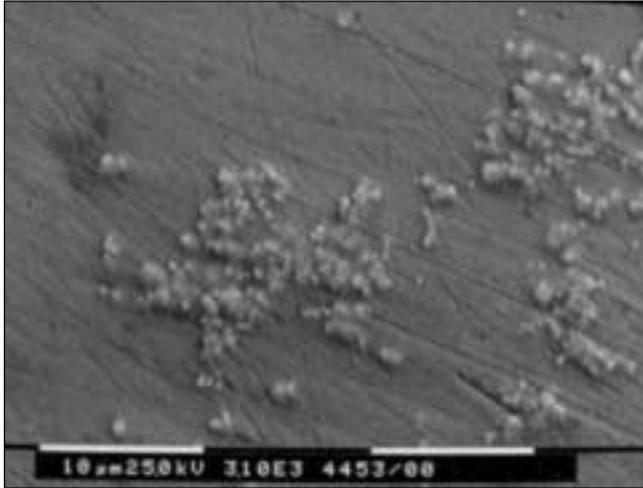
Figure 5: Detail of figure 4 at higher magnification
Figura 5: Dettaglio della figura 4 a maggiori ingrandimenti

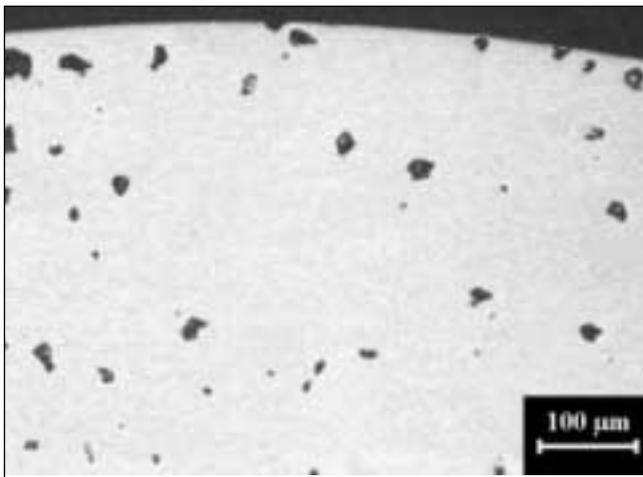
Figure 6: Typical gas porosity from SO₂
Figura 6: Tipica porosità da gas da SO₂

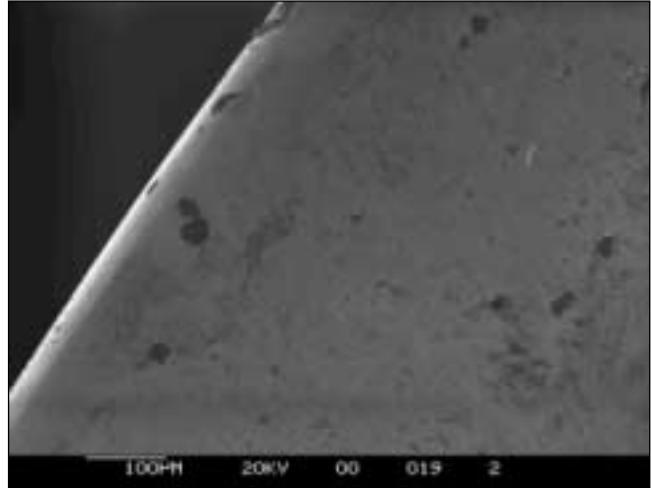
Figure 7: Rounded SO₂ porosity located at the surface of the sample
Figura 7: Porosità tondeggianti da SO₂ situate nella zona superficiale del campione

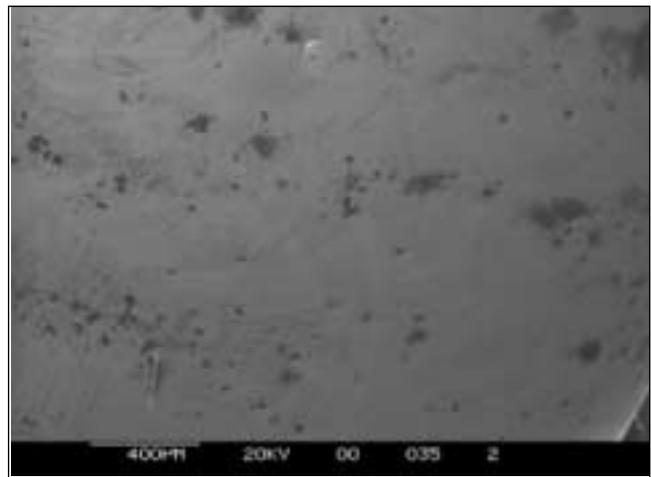
Figure 8: Rounded pores located near the surface
Fig. 8: Porosità arrotondate collocate in prossimità della superficie

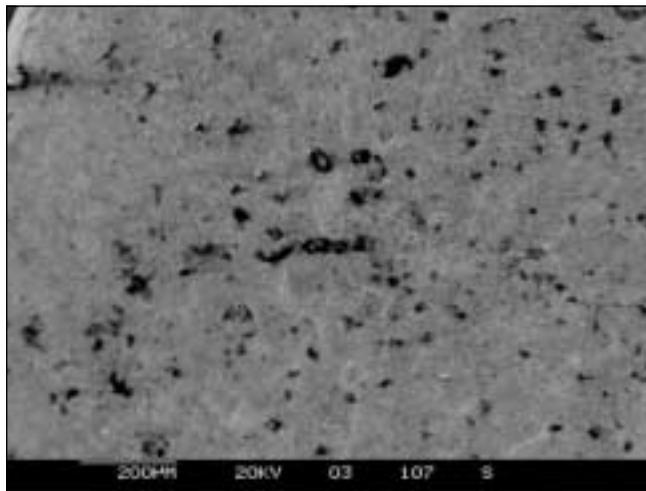
They are mainly due to the presence of copper oxide inclusions, generally introduced through the re-use of scraps during the preparation of granules.

The aspect of this defect can be confused with shrinkage porosities; anyway its different nature can be related to the presence of CuO. Copper oxide, whose stability is strictly dependent on temperature, modifies its equilibrium with copper during solidification with the release of oxygen, generating porosities. It is therefore necessary to use precautions to minimise this problem, such as casting under non oxidising atmosphere, limiting to 50% max the quantity of recycles and, most of all, take special care of the "cleanness" of these latter, with the final aim of reducing the presence of oxides.

Figure 9: Example of porosity deriving from the presence of CuO ; bigger pores are evident in the centre of microstructure

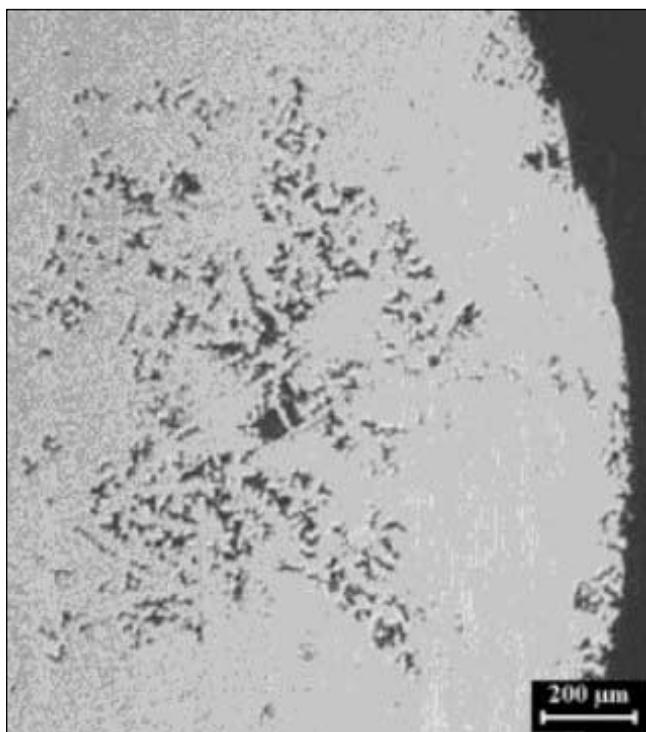
Figure 10: Example of porosity related to shrinkage

Figure 10 shows typical shrinkage porosity.

Differently from what happens for gas porosity, in this case a deep influence on mechanical properties is present: a “spongy” and porous structure near a critical area of the finished product locally reduces the mechanical resistance, with the real possibility of having ruptures even with low applied loads. A proper change of the burn out and of casting temperatures may partially contribute to avoid the premature solidification of additional molten metal, provided to compensate shrinkage.

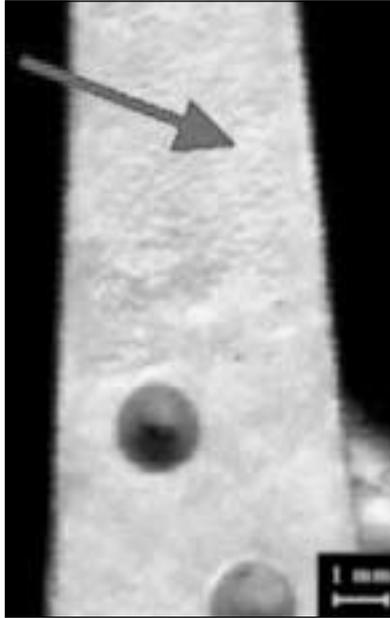
The object surface is then rough (figure 11), while at the borders micro-cracks form in the refractory; molten metal penetrates in these areas and determines irregular shaped slobbers (figure 12).

Figure 11: The arrow indicates a sandblast area located at the top of the object

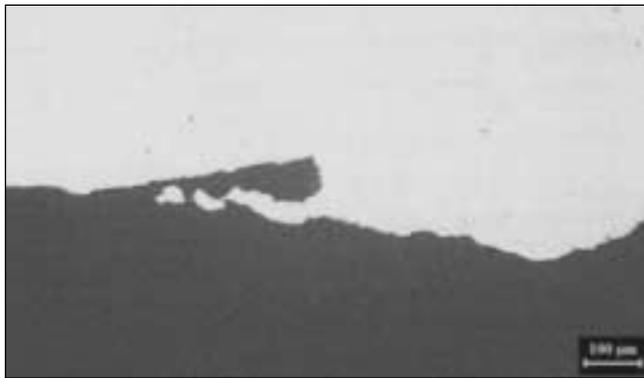
Figure 12: Typical example of slobber

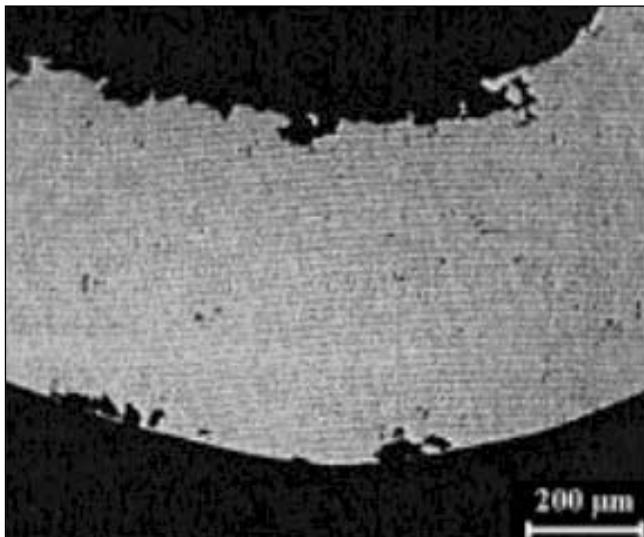
Figure 13: Porosity deriving from refractory inclusions

Figure 13 shows a typical example of cavities/ poor surfaces deriving from the presence of inclusions.

During castings, the melting metal can partially remove part of the investment, especially in presence of turbulent flow. Non metallic particles are then trapped into the object as inclusions. The causes for the refractory crumbling have to be searched in the poor quality of investment powder or generally in some mistakes during the preparation of the tree, with the positioning of edges in critical areas as, for example, in the central gate joining points.

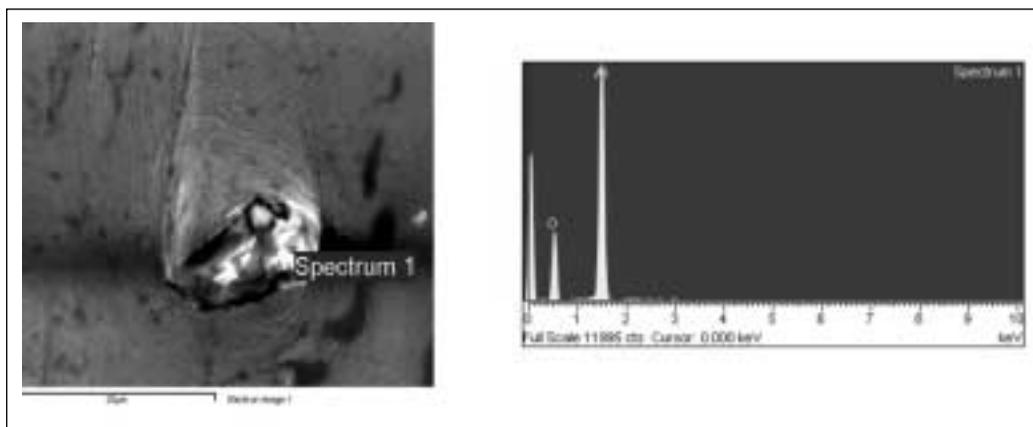
A similar defect, although deriving from a totally different cause is shown in the following figure 14. In this case, as before, it is present a non-metallic inclusion, as it can be easily seen in the analysis spectrum but differently from before, the defect composition cannot be related to a refractory decomposition. Alumina can derive, in general, from operations carried out before the preparation of the alloy as, for example, from previous finishing operation on the alloy then recycled. It could

Figure 14: Non metallic alumina based inclusion

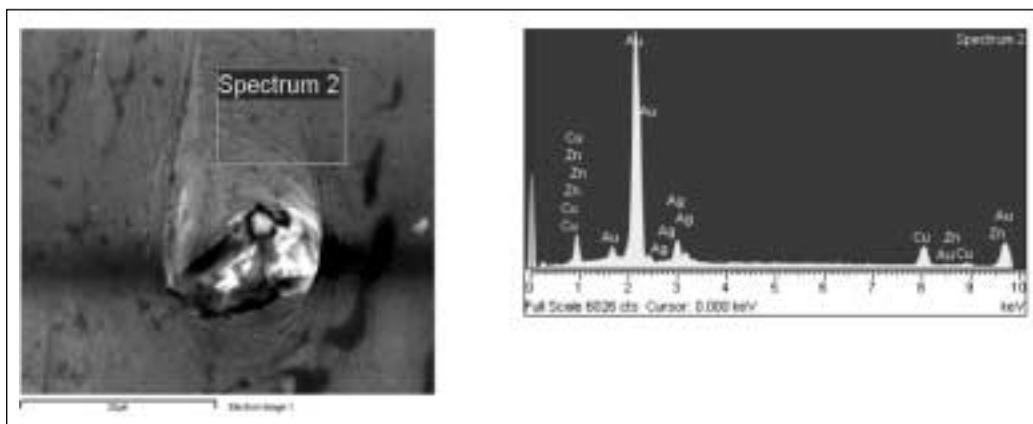
Figure 15: Analysis of the alloy located close to the non-metallic inclusion

have been brought to surface during finishing processes. The second analysis (Fig. 15), performed in the surroundings of the previous one, underlines that the problem is deriving from an external problem and not from an incorrect preparation of the alloy.
