Knock (and pre-ignition) damage on engine components: case studies

E. Balducci, S. Parisi, F. Boccia, M. Barichello, L. Ceschini

KEYWORDS: KNOCK - AUTOMOTIVE PISTON - COMBUSTION CHAMBER COMPONENTS - FAILURE ANALYSIS

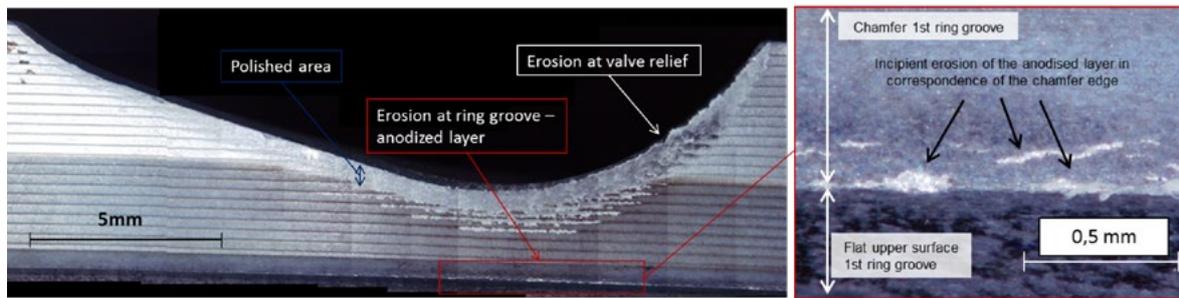
More interesting from a technical point of view and challenging in terms of both materials research and engine control strategies is a medium knocking level. The result of a persistent condition of medium knocking combustions is shown in Fig.1: the occurrence of a sliding contact between cylinder and piston valve relief is perceivable in the upper polished area, while the jagged edge of the valve relief shows a moderate erosion. An incipient erosion is also perceivable at piston ring groove, highlighted by arrows at higher magnification: the ring groove is a crevice area, a potential site of knock triggering since it collects the end-gases furthest from the spark-plug [8,9,12], moreover the hard and brittle anodized layer is extremely sensitive to knock pressure waves. It should be also highlighted that the anodized layer grows thanks to Al passivation, therefore it hardly covers eutectic Si or primary Si crystals, which form weak points [8,13]. SEM-EDS investigations have been carried out on the area highlighted in red in Fig.1, in order to depict the first stages of the anodized layer damage. The results are reported in Fig.2: small cracks are observed at ring groove edge, highlighted by the arrows, and EDS analyses in correspondence of cracks show a higher Si content, confirming the presence of primary or eutectic Si crystals beneath.

Fig.1 -Hirox image of an automotive piston intake valve relief. Erosion is perceivable both in the upper part of the valve relief (see jagged edge) and in the ring groove (white discoloration). Image from a turbocharged V8 engine.

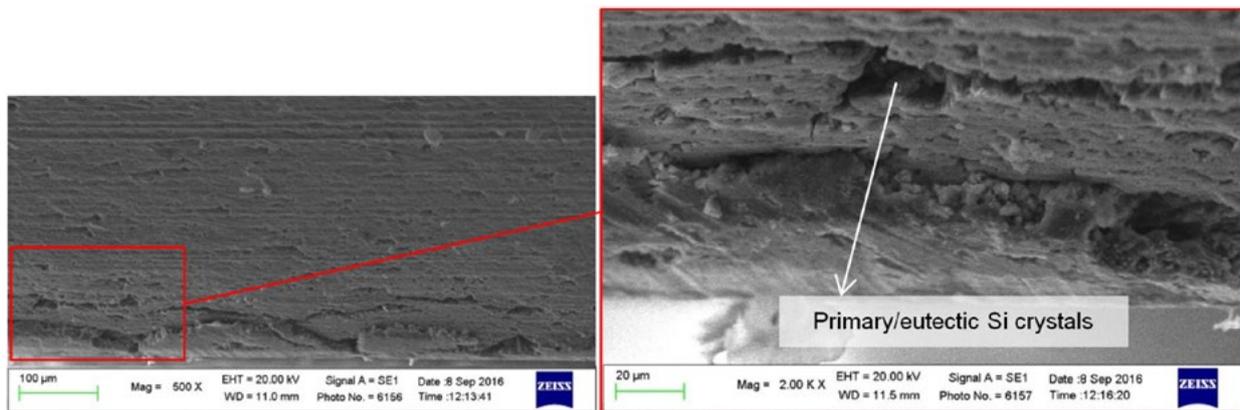
Fig.2 -SEM micrographs of the 1st ring groove anodized layer, characterized by incipient erosion. EDS analyses revealed the presence of a higher amount of Si beneath the cracks. Image from a turbocharged V8 engine.

Even if no consequences are perceived at the initial stages of the anodized layer erosion, this damage might obstruct the 1st ring functionality. A persistent erosion process might produce a total wear of the anodized layer, leading to a direct contact between the 1st ring and piston Al alloy. Under these conditions, the 1st ring is prone to sticking to the lower flank of the ring groove due to the high pressure and temperature induced by combustion, inevitably resulting in

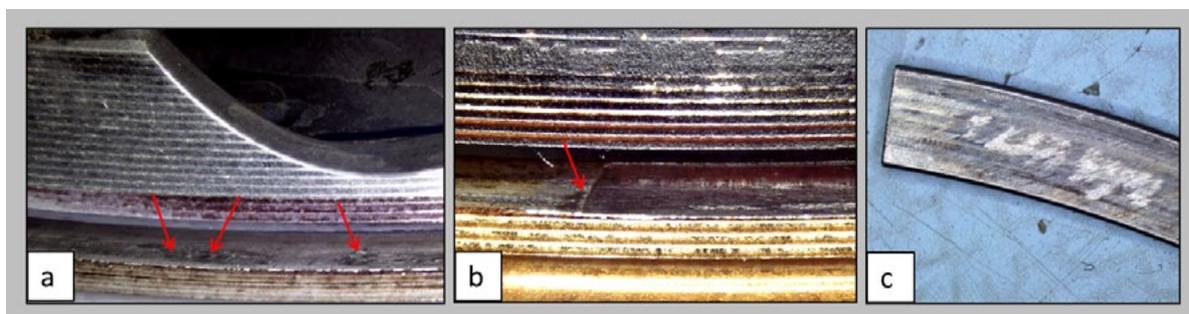
power loss and lower combustion efficiency. Typical images of ring sticking are reported in Fig.3. In case of heavy wear of the anodized layer, several micro-welding spots can be observed (arrows in Fig.3a). At higher pressure/temperature, the damage is rapidly intensified, leading to a complete ring sticking (Fig.3b); an Al transfer layer, typical of adhesive wear, is also perceivable on piston ring (Fig.3c), and confirmed by SEM-EDS analyses (here not reported).

Fig.3 -Stereo-microscopy micrographs depicting 1st ring – piston welding. (a) Micro-welding spots (pointed by arrows) and Al plastic deformation. (b) Noticeable sticking area at the 1st ring groove. (c) Evidences of piston material deposited on piston ring.

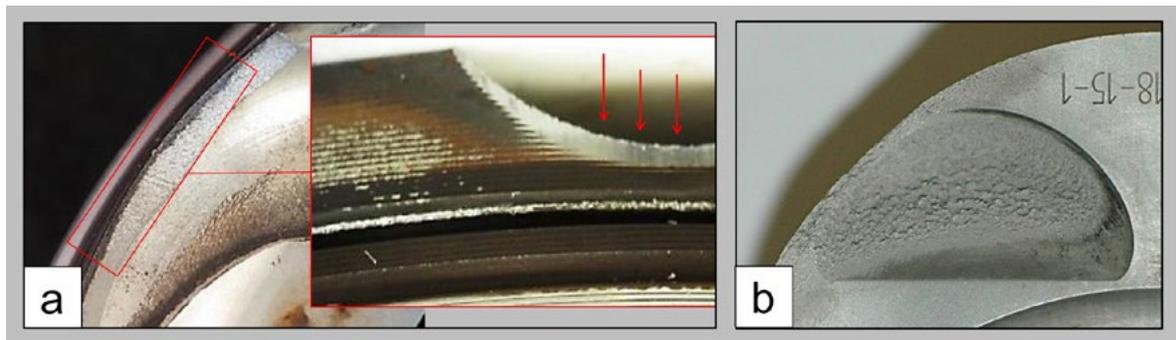
locking. It is usually observed a correlation between plastic deformation and erosion of the valve relief over a certain threshold. An example of that is reported in Fig.4: a tiny ring groove deformation (order of magnitude 10^{-2} mm) corresponds to a middle level erosion of valve relief (Fig.4a), while an increased deformation characterizes the heavily eroded exhaust valve relief reported in (Fig.4b). Ring groove closure should be mainly considered a consequence of knock-increased thermal and mechanical loads, which induce deformation of

piston top land towards the con-rod. It should be pointed out that the dimensional changes of the ring groove are frequently observed in combination with valve reliefs erosion, regardless of 1st ring groove erosion: the peaks of eroded material in the ring groove, locally reducing the clearance, provide a very small contribution to ring locking. As well as micro-welding, this is considered a fatal piston damage, since it compromises the combustion gases sealing.

Fig.4 - Images of two pistons valve reliefs characterized by ring groove plastic deformation, V8 turbocharged engines. (a) Stereo-microscopy images at the intake valve relief, medium knocking erosion and tiny ring groove closure. (b) Macrograph at the exhaust valve relief, heavier knocking conditions: erosion is more pronounced, as well as ring groove closure.

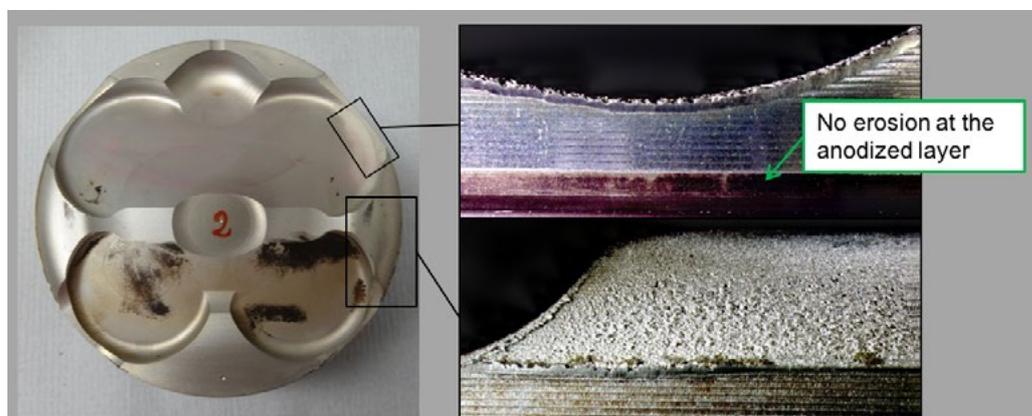
However, as well as pistons equipping turbocharged engines, knock-induced erosion is typically observed at piston valve reliefs. An example of middle-high level erosion is reported in Fig. 5: it should be pointed out that no deformation of the ring groove is detected and no damage is observed at the anodized layer, even if both polishing and erosion are clearly perceivable, indicating the occurrence of knocking combustions.

Fig.5 - Knock induced erosion (middle level) in an automotive piston belonging to a naturally aspirated engine. Stereo-microscopy micrographs focus on intake valve relief and piston pin axis side; no damage of the anodized layer at the 1st ring groove is observed.

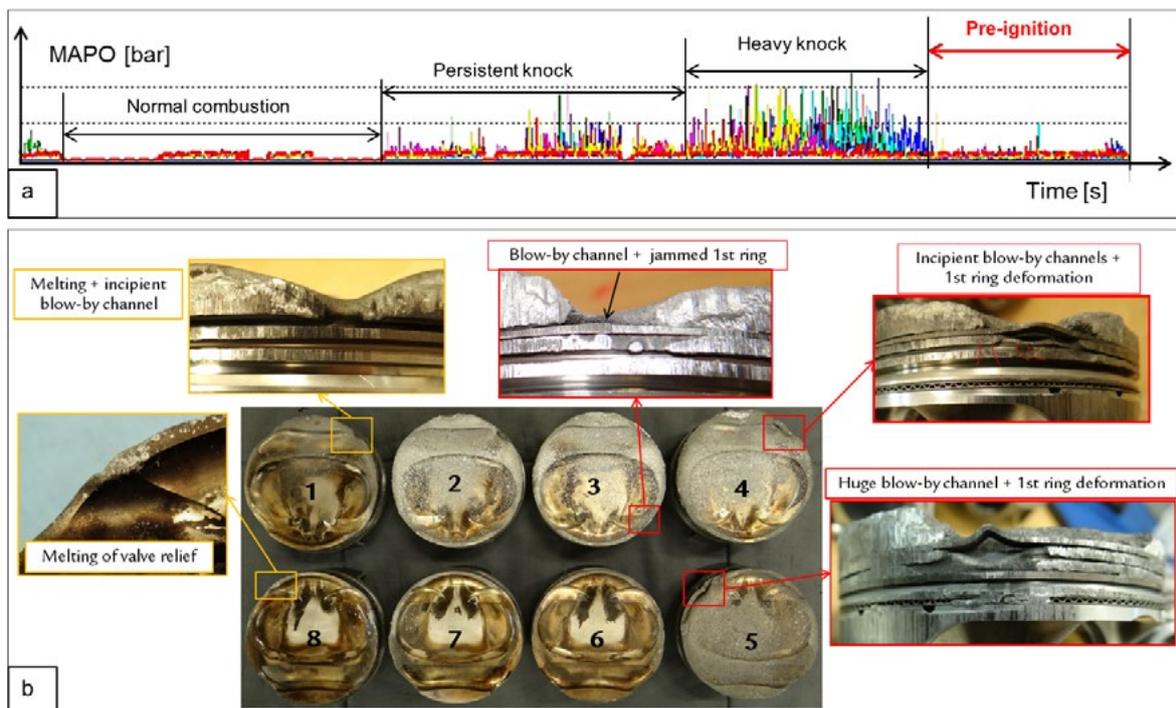
pre-ignition occurrence. A V8 turbocharged engine, without a calibrated knock control strategy, was involved. The effects of this sequence on the 8 pistons are shown in Fig.6b and here schematically described:

- At all Al pistons heads, melting signs are observed, often resulting in the formation of blow-by channels; under these conditions, also other combustion chamber components are covered by molten Al spots, such as injectors, spark-plugs, cylinder liners and heads.
- The significant temperature increase and induced thermal expansion produce seizure marks, perceivable at all pistons lands, in particular at pin axis side for the absence of piston skirt constraint.
- In the severest cases, 1st ring is completely jammed or subjected to a substantial plastic deformation.

Fig.6 - Degeneration of severe knocking combustions into pre-ignition sequence. (a) In-cylinder pressure signal, filtered in order to show MAPO parameter (MAPO explanation in [6]). (b) Effects on pistons of severe knocking combustions + pre-ignition.

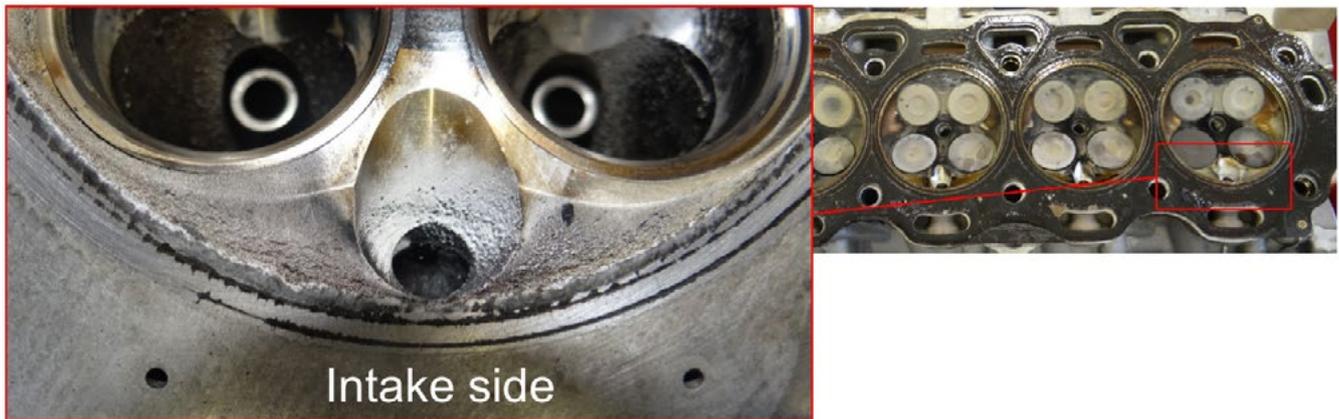
typical knock damage of Al cylinder heads is limited to surface erosion, as reported in Fig.7: in this case, the intake side is involved. Erosion at cylinder head does not usually compromise engine functionality, until the integrity of its cooling channels is preserved. This damage is however rarely observed and it is a marker of persistent high-level knocking combustions, which should be avoided.

Fig.7 -Macrographs reporting erosion at cylinder heads, V8 turbocharged engines.

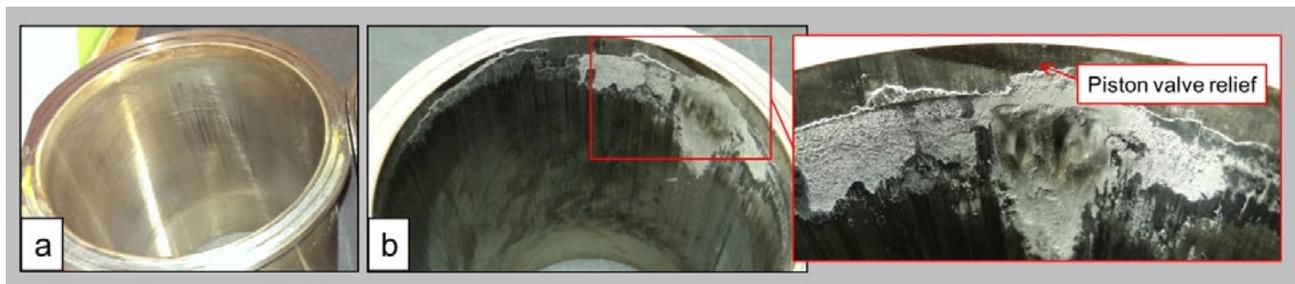
Even if made by steel and Nikasil coated, cylinder liners as well might also be affected by knock. The damage is mainly related to the knock-induced overheating, which leads to a reduced functionality of lubricants, possible breakdown of the lubrication film and significant piston thermal expansion, though localized and limited to piston top land in case of efficient knock control strategy (see tiny seizure marks in the thrust and anti-thrust side in Fig.8a). In case of repeated knock and pre-ignition, the insufficient clearance between the matching surfaces and the resulting friction further intensify the heat-induced expansion, finally resulting in complete piston seizure. Such destructive effects are reported in Fig.8b: several seizure marks are visible on cylinder liner, together with transferred Al material. It is interesting to point out that also

melting of the liner is visible at the TDC, beneath the location of piston valve relief, which is supposed to be the hot spot triggering knocking and pre-ignition combustions. Also spark-plugs might be affected by severe knock or pre-ignition and their damage inevitably compromises the combustion process. In particular, partial rupture of the ceramic insulator due to thermal shock might be produced by increased thermo-mechanical stresses (Fig.9a); in this case, usually spark leaks can be observed, indicating reduced spark plug functionality. Al deposits coming from pistons are usually observed, while melting of the electrodes and ceramic insulator is perceivable in the severest abnormal combustions, due to higher thermal loads.

Fig.8 - Macrographs reporting cylinder liners damage. (a) Tiny seizure marks (severe knock but efficient knock control). (b) Heavy seizure marks due to knock + pre-ignition; in addition, transfer of Al and partial melting under valve relief location are observed.

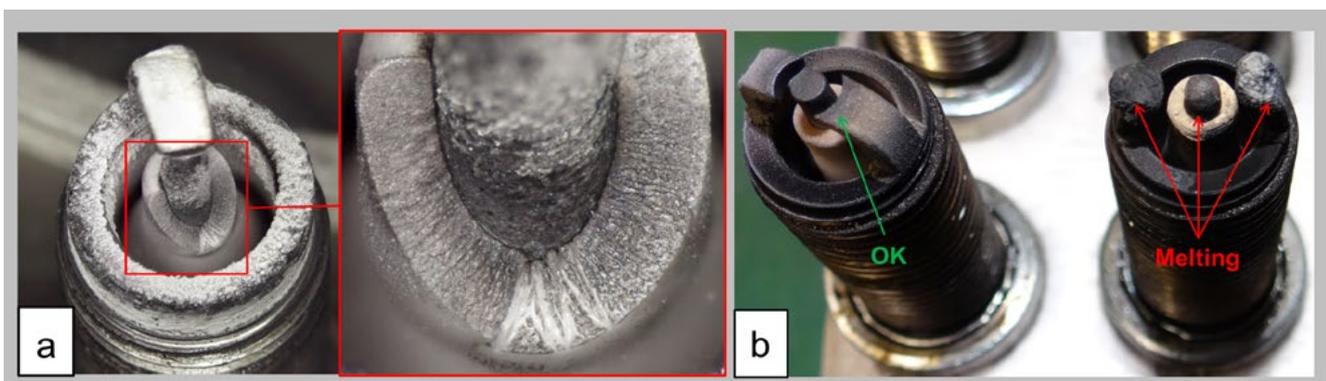
Fig.9 - Spark plugs damage due to knock or pre-ignition. (a) Breakage of ceramic insulator and spark leaks. (b) Electrodes melting.
