HOW HEAT TREATMENT CAN GIVE BETTER PROPERTIES TO ELECTROLESS NICKEL-BORON COATINGS

V. Vitry, F. Delaunois, C. Dumortier

Electroless nickel-boron deposits were synthesized on mild steel and submitted to heat treatments under neutral and nitrogen based atmosphere. The properties obtained after these treatments were compared to as deposited nickel-boron coatings. The morphology and structure of the samples were investigated by XRD, SEM and optical microscopy; their composition was studied by ICP, GD-OES and SIMS analysis, and micro and nanoindentation tests were carried out to assess the coatings' hardness. Scratch tests were used to determine the damage mechanisms of the coating.

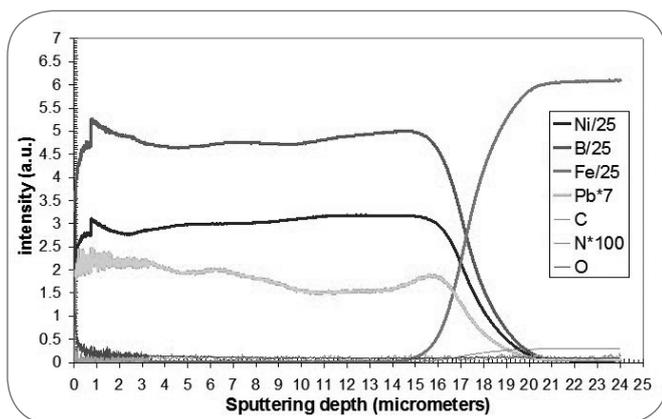
Fig. 1
GD-OES depth profile of an untreated nickel-boron coating on Steel.
 Profilo GD-OES nello spessore di un rivestimento nichel-boro non trattato su acciaio.

GD-OES analysis, on steel substrate, allowed us to follow qualitatively the composition into the depth of the coating. In the as-plated state (Fig. 1), the boron and nickel content of the coating don't vary with the depth while the lead content seems to be higher at near the substrate interface then decreases slightly before increasing once more. It means that more lead is deposited at the very beginning of the process and at the end that during the fast "regime" deposition of the coating.

Observation of the interface allows us to predict a good adhesion of the coating because there seems to be a certain amount of interdiffusion with the substrate.

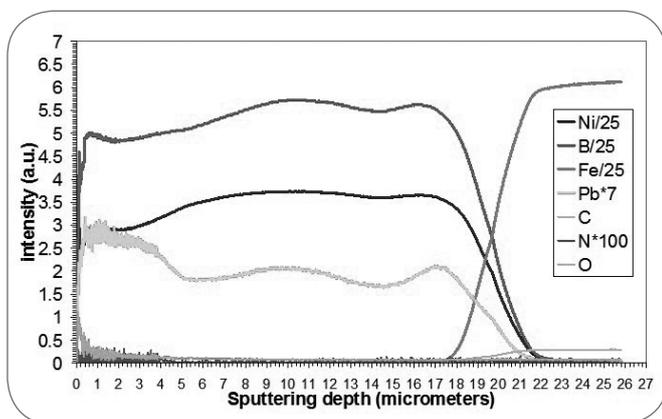
Fig. 2
GD-OES depth profile of a nickel-boron coating on Steel after 1 hour heat treatment at 400°C under neutral atmosphere.
 Profilo GD-OES nello spessore di un rivestimento nichel-boro su acciaio dopo 1 ora di trattamento termico a 400°C in atmosfera inerte.

After heat treatment at 400°C for one hour under neutral atmosphere (Fig. 2), the nickel and boron content are quite unmodified while the lead content becomes higher near the free surface of the sample and decreases steeply with depth. The lead seems to diffuse outside the coating. However, the interface between the steel substrate and nickel-boron was not modified by this treatment. Previous work revealed important interdiffusion at the interface after heat treatment in the case of aluminium-silicon alloys (AS7G06) [15].

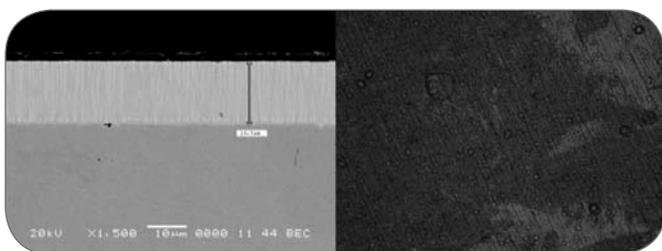
Fig. 3
SEM micrograph of an untreated nickel-boron coating – left: cross section showing the columnar morphology – right: cauliflower-like surface.
 Micrografia al SEM di un rivestimento nichel-boro non trattato – sinistra: sezione trasversale che mostra una morfologia colonnare – destra: superficie "a cavolfiore".

In the as-deposited state, the coatings present a columnar morphology and a cauliflower-like surface (which is characteristic of nickel-boron coatings [11,15,17]), as can be seen on Fig. 3. Neutral atmosphere heat treatments up to 400°C do not modify those properties.

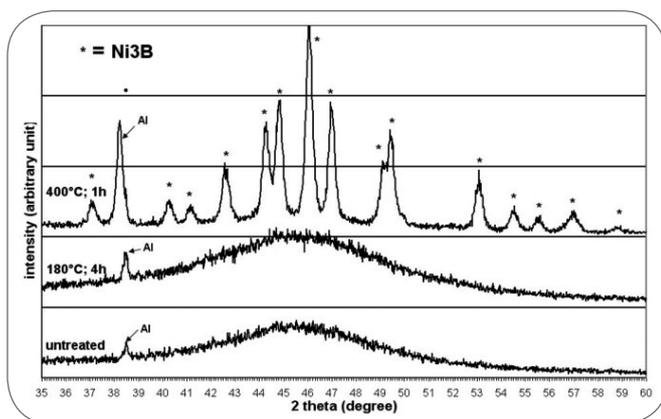
Fig. 4

X-Ray diffraction patterns of Electroless nickel-boron coatings on aluminium substrates with and without heat treatments.

The structure of untreated samples and samples treated at 180°C revealed they were amorphous (Fig. 4) while crystallization occurred during heat treatment at 400°C. This is expected from the literature and our own previous results [2,15,19,30].

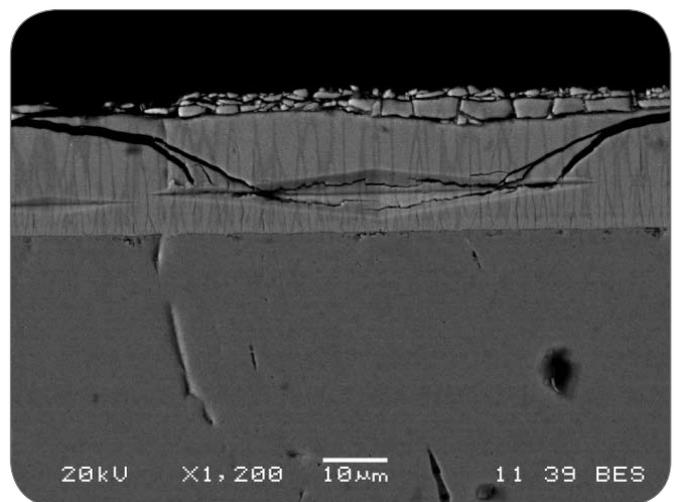
Fig. 5

Cracking of the coating caused by Knoop indentation.

It was not possible to obtain a reliable Knoop hardness value after treatment at 400°C because cracking of the coating occurred. This shows the importance of comparing values from different techniques: Nickel boron coatings have a very anisotropic structure, due to their synthesis mode. Vickers hardness is carried out in the growth direction of the coating and any damage occurring during this test will remain unseen because it will take place inside the coating. However, Knoop indentation is made perpendicular to the growth direction of the coating and the subsequent damage is easily observable (Fig. 5). Knoop indentation is thus more reliable. This may also explain why na-

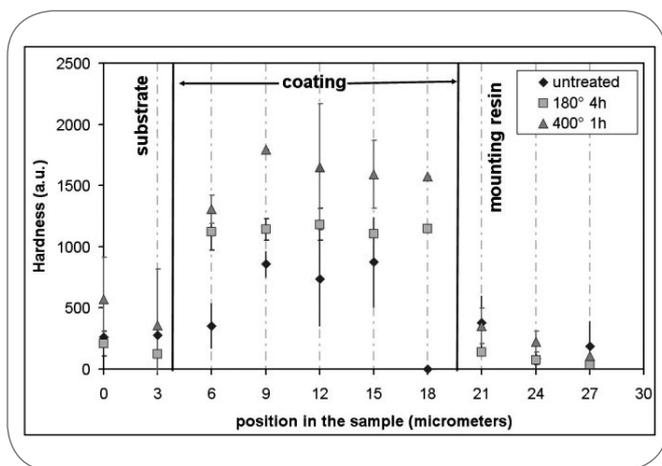
▲
Fig. 6

Nanoindentation profiles on treated and untreated nickel-boron coatings.

The small size of nanoindentation indents allows measuring the hardness of the coating on several points across the coating without any interaction of the indents. We were thus able to draw hardness profiles for nickel-boron coatings (fig. 6). Those profiles showed that the hardness values are not homogeneous across the coating except after heat treatment at 180°C. This is probably due to the fact that as-deposited coatings have important internal stress. Heat treatment at 180°C releases a lot of this stress and the hardness becomes homogeneous. Heat treatment at 400°C however may generate new internal stresses because it is accompanied by important structural modifications. Moreover, as nanoindentation is a very sensitive experimental method it is possible that part of the values scattering is due to external factors such as roughness of the sample (microscratches in the

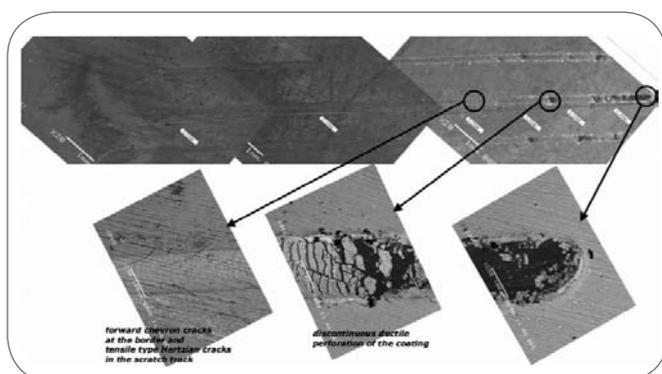
▲
Fig. 7

Micrograph of scratches on 6 μm thick nickel-boron coatings (aluminium alloy substrate) without heat treatment.

The damage mechanisms were the same for both treated (Fig. 8) and untreated (Fig. 7) coatings which is not surprising knowing they present roughly the same structure and morphology. The first failure that was observed is longitudinal cracking on the edges of the coating. Chevron cracks were then observed. Those are cohesive damage. The first adhesive failure is discontinuous ductile perforation of the coating, which is followed, in the case of heat treated samples, by continuous ductile perforation of the coating. To observe this kind of failure is really encouraging because it is a proof of the good adhesion of the coating, which was first suggested by the interface observation by GD-OES. Moreover, this failure was only observed because the coating was so thin.

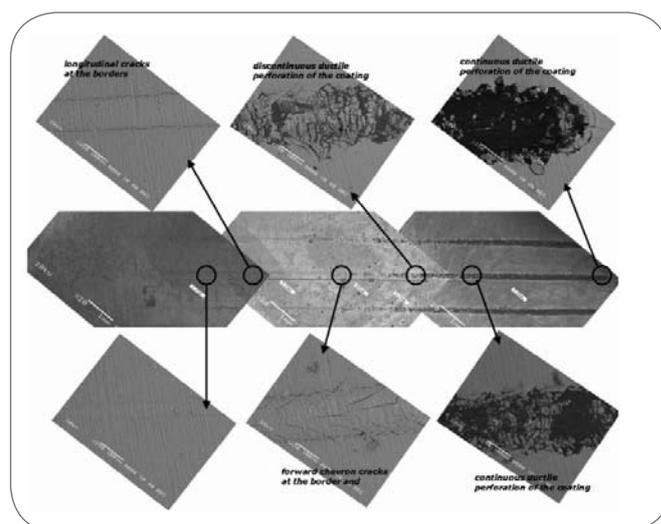
▲
Fig. 8

Micrograph of scratches on 6 μm thick nickel-boron coatings (aluminium alloy substrate) after 4 hours at 180°C under 95% Ar + 5% H₂ atmosphere. Micrografia di scalfiture su rivestimenti di nichel-boro dello spessore di 6 μm (substrato in lega di alluminio) dopo 4 ore a 180°C in atmosfera 95% Ar + 5% H₂.

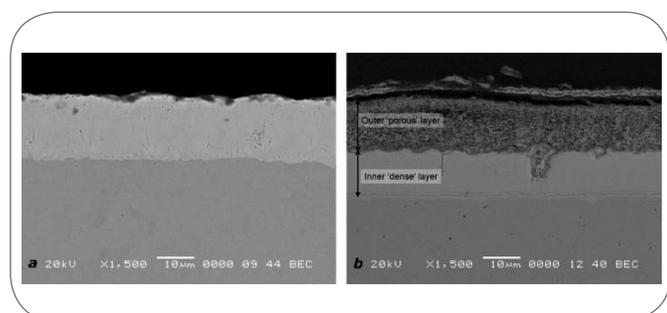
Fig. 9

SEM micrograph of (a) a "vacuum" treated and (b) an "ammonia" treated nickel-boron deposit on steel substrate.

SEM cross section micrographs of nickel-boron coatings after "vacuum" and "ammonia" treatments showed an important morphological modification of the coating: it becomes totally dense after "vacuum" treatment and the columnar morphology disappears completely (Fig. 9a), and the coating is composed

of 2 distinct layers after "ammonia" treatment (Fig. 9b). The inner layer is dense and resembles the "vacuum" treated coating while the outer layer looks porous.

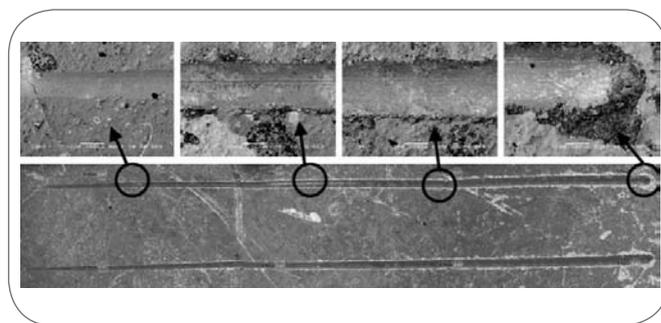
Fig. 10

Scratch test on an "ammonia" treated nickel-boron coating.

Scratch tests were carried out on "ammonia" treated coatings. Those coatings, while they are plastically deformed, are nearly undamaged after the tests (Fig. 10) which is promising for wear applications.
