Indoor and outdoor atmospheric corrosion monitoring of cultural heritage assets

E. Angelini, C. E. Arroyave Posada, E. Di Francia, S. Grassini, L. Iannucci, L. Lombardo, M. Parvis

Storia della metallurgia e beni culturali

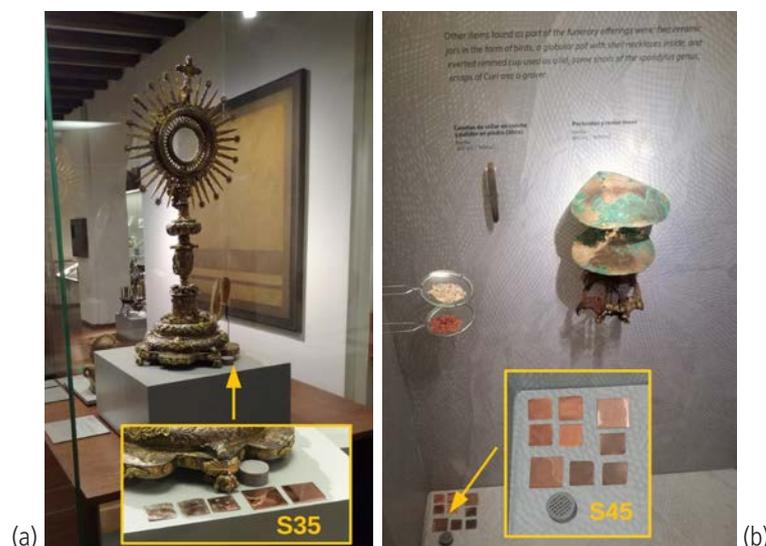
Fig. 3 – Sensors and Cu reference samples positioning in the National Museum of Colombia. (a) sensor S35 located in room 13; (b) sensor S45 located in room 6.

Fig. 3 shows two of the showcases, under study, with bronze and gold artefacts, where the sensor nodes S35 and S45 have been placed. Sensor S35 is located in room 13, "Custodia", a large room at the first floor. The image inset also shows a details of the Cu coupons. Sensor S45 is located in room 6, Boveda 'El oficio del Orfebre', in the showcase 'Tumba de pozo con camara', an armored room, at the ground floor.

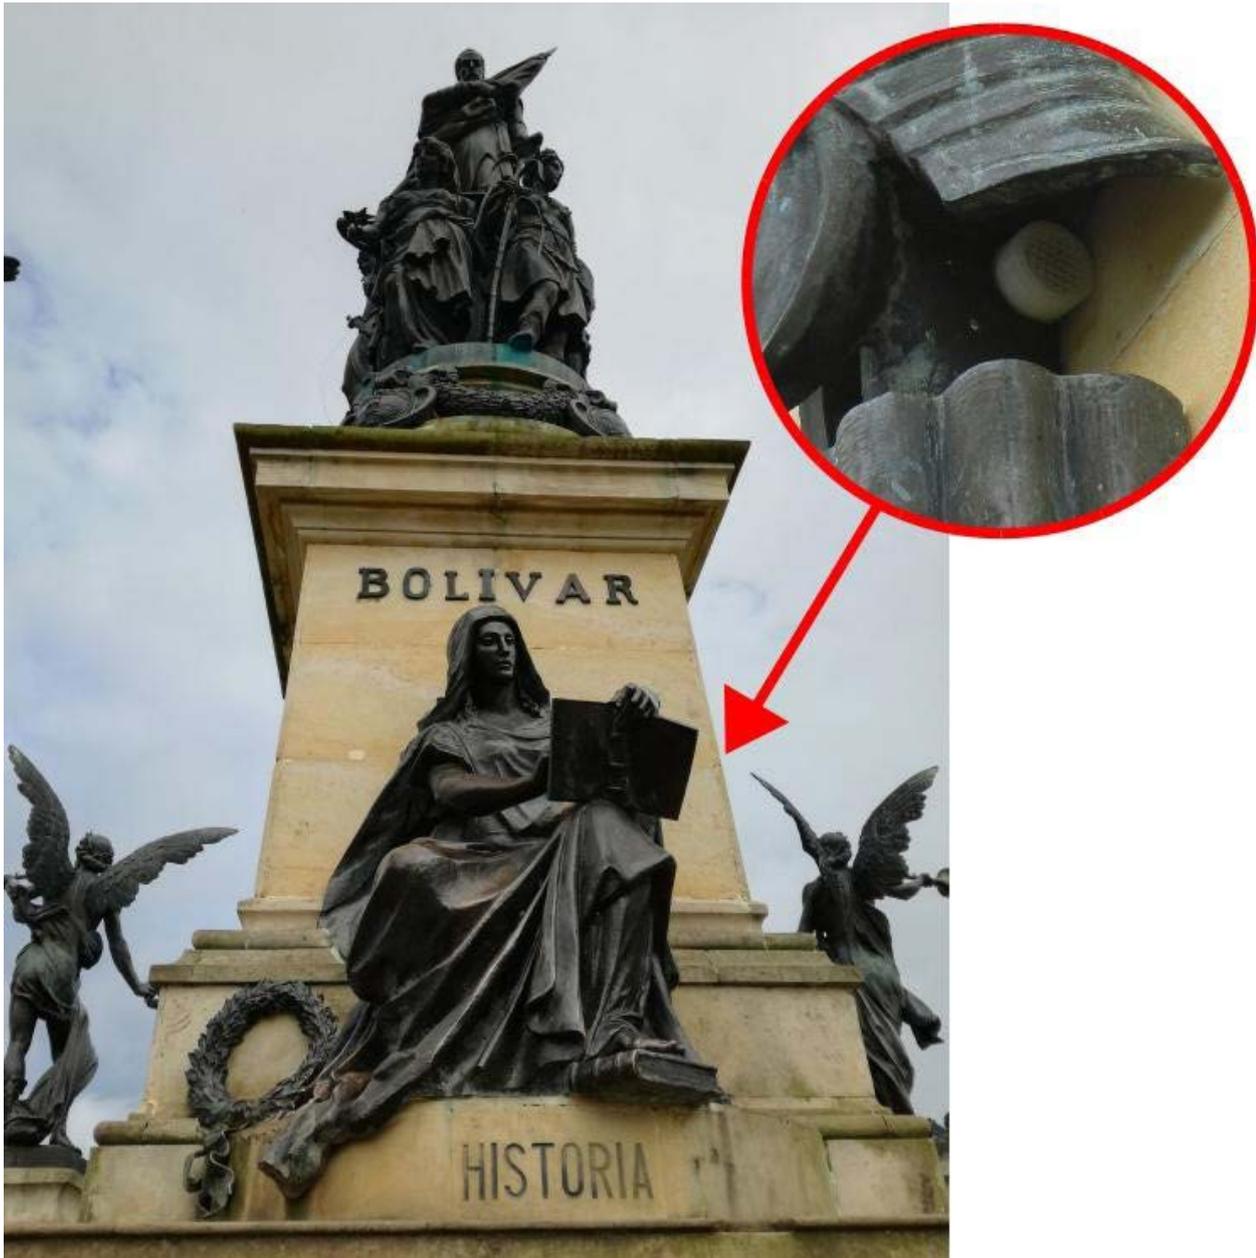
Fig. 6 – The Simon Bolivar bronze statue in the Puente de Boyacá, an historical site built in the early 18th century, memorial of independence in 1920.

statue of Francisco de Paula Santander, the monument of Pedro Pascasio Martínez and, on the hill, the Von Miller Monument are also part of this important historical site. The Von Miller Monument, shown in Fig. 6, is a bronze monument composed by five allegoric female figures, symbolic of Colombia, Venezuela, Peru, Ecuador and Bolivia, holding Simón Bolívar (1783-1830), the liberator from the Spanish government and the first president of Gran Colombia.

The bronze statues of the Von Miller monument are apparently in a quite good conservation state even if tourists are allowed to climb the monument, risking of removing the surface patina grown on the metal by the interaction with the atmosphere. However, this anthropic damage is less important respect to
