# Fatigue properties and microstructural analysis of diecast AlSi11Cu2(Fe) alloy: effect of surface finishing

M. Merlin, D. Benasciutti, L. Lattanzi, A. Fortini, G. Timelli

In the present work, a secondary AlSi11Cu2(Fe) alloy was diecast by means of a specifically designed die. Specimens with both the as-diecast surface quality and after sand-blasting were prepared and subjected to uniaxial fatigue tests in order to investigate the effect of surface finishing on S-N curves. The S-N curves for the two different surface finishing were estimated and compared in terms of inverse slope  $k$  and amplitude strength  $\sigma_A$  at  $5 \times 10^6$  cycles. Experimental data for the two different surface finishing showed a similar statistical dispersion in fatigue life. Nevertheless, amplitude strength  $\sigma_A = 73$  MPa and S-N slope  $k = 25.8$  were obtained for sand-blasted samples, which are higher than the corresponding  $\sigma_A = 62$  MPa and  $k = 11.4$  showed by the as-diecast samples. After fatigue testing, both fracture profiles and surfaces were studied by optical and scanning electron microscopy to correlate crack initiation and propagation with fatigue strength. The

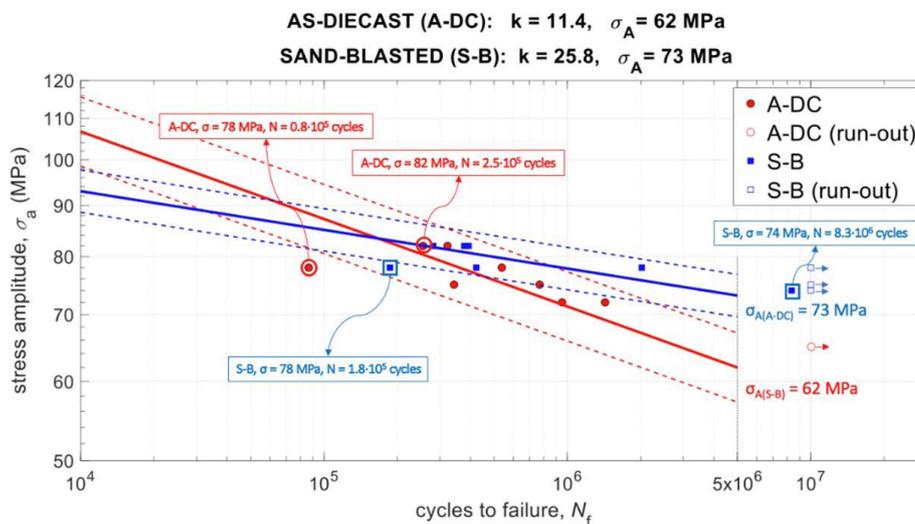
Figure 1 displays the results of the fatigue tests for both the as-diecast and the sand-blasted samples. The S-N curves for the two different surface finishing were estimated in terms of the inverse slope  $k$  of the linear regressions. The amplitude strength  $\sigma_A$  at  $5 \times 10^6$  cycles was assessed, as well as the scatter bands at 10% and 90% of survival probability. Regardless of the surface finishing, the results show a similar statistical dispersion in fatigue life. The values of amplitude strength  $\sigma_A = 73$  MPa and S-N slope  $k = 25.8$  obtained for sand-blasted samples are higher than the corresponding  $\sigma_A = 62$  MPa and  $k = 11.4$  shown by the as-diecast samples.

Fig.1 - S-N curves for as-diecast and sand-blasted specimens.

ce finishing induced by sand-blasting, in agreement with the measured roughness values. Moreover, the microstructure of the sand-blasted sample is clearly modified for the thickness of a few tens of microns below the surface. This may explain the improved fatigue behaviour of the alloy obtained in the fatigue tests (Fig.1).

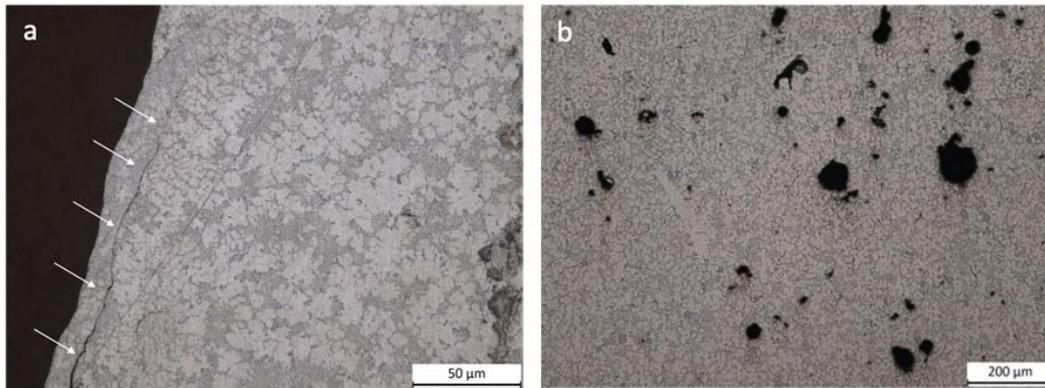
**Fig.2** - OM micrographs of typical casting defects observed in the as-diecast samples: a) lamination and b) air/gas porosities.

In particular, the presence of lamination near to the casting surface (Fig.2a) as well as air/gas porosities close to the centre (Fig.2b) of the samples were observed; these defects can strongly affect the dynamic mechanical properties of the alloy.

the material were studied by OM on both longitudinal and transverse sections of the samples (Fig.2). Casting defects typically of high-pressure die-casting process were detected.

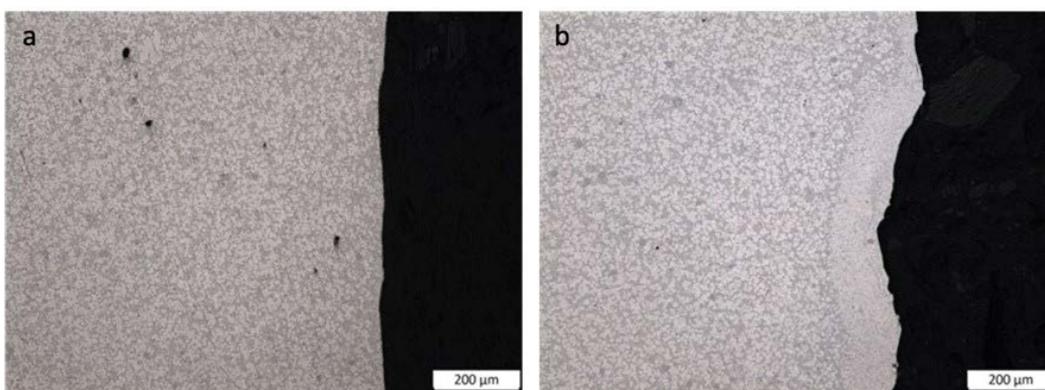
The micrographs of the longitudinal sections of as-diecast and sand-blasted samples in Fig.3 show the different surfa-

**Fig.3** - OM microstructure and surface finishing of the longitudinal section of a) as-diecast and b) sand-blasted samples.

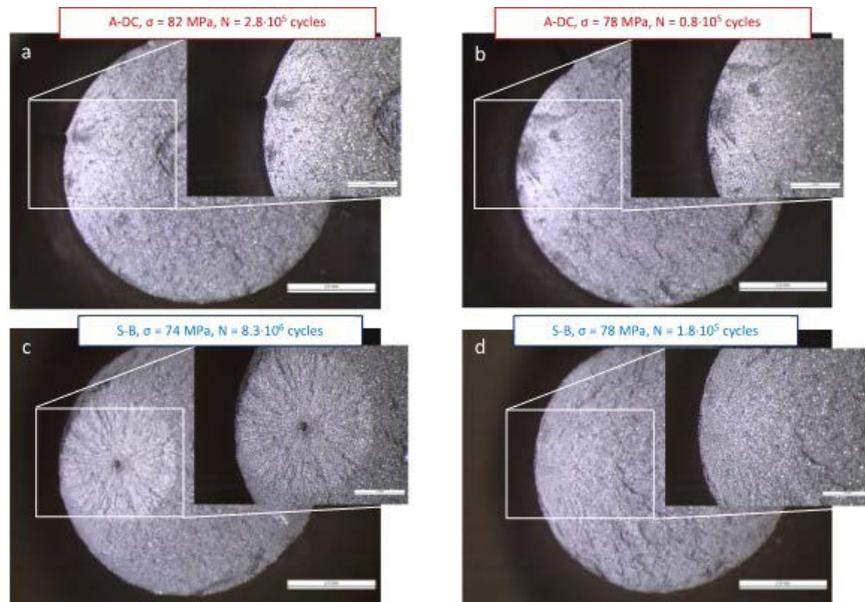
that played a significant role in the fracture mechanism. Figure 4 depicts the images of the fracture surfaces of four different tested samples with detail at higher magnification of

the initiation site. The number of cycles at failure for each sample is also highlighted in Fig.2. Among all the tested samples, the sand-blasted sample in Fig.4c is characterised

by the highest number of cycles at failure and the initiation site can be identified as an internal defect.

**Fig.4** - Fracture surfaces of four different samples: a,b) as-diecast and c,d) sand-blasted samples.

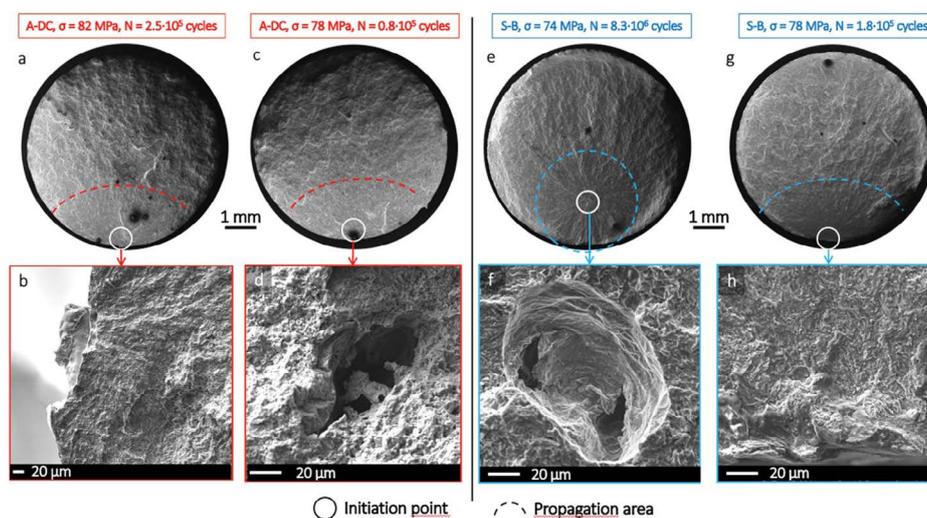
Fractographic analysis performed by SEM showed that, for as-diecast samples, the surface defects or sub-cortical pores provided sites for fatigue crack initiation. In Fig.5a it is possible to observe that the initiation of the fatigue fracture occurred at the flash generated by the parting line of the die (Fig.5b). In other samples, the initiation of the crack is promoted by the presence of sub-surface defects, such as porosities (Fig.5c and 5d).

Considering the sand-blasted samples (Fig.5e and 5g), the crack mainly initiated from internal defects such as porosities (Fig.5f) or cold joints (Fig.5d), generated by the die-casting process; overall, the samples that showed a longer fatigue life were those with the crack initiated from internal defects. This result is due to the compressive stress on the surface defects that is caused by sand-blasting.

**Fig.5**- Fracture surfaces of four different samples: a,b) as-diecast and c,d) sand-blasted samples.
