# Corrosion behaviour in acidic environments of alloy 625 produced by Material Extrusion: effect of the process-generated microstructure and defects

T. Persico, S. Lorenzi, M. Cabrini, L. Nani, T. Pastore, G. Barbieri, F. Cognini

Additive manufacturing (AM) is gaining increasing interest in various strategic industrial sectors such as Oil & Gas, aerospace, and chemical industries. This group of technologies includes both innovative yet well-established techniques and more recent methods like Material Extrusion (MEX). This technique shows several advantages over other AM techniques, including high deposition rates and simplicity in feedstock material handling; however, it presents numerous endogenous macro-defects that can affect the corrosion resistance. The relationship between the defects of this technology and its corrosion behaviour still needs to be thoroughly investigated. This work studies the relationship between microstructure, internal defects, and corrosion behaviour in reducing acidic environments of alloy 625 obtained through MEX, compared to the same alloy obtained with traditional technology. The results lay the groundwork for further studies aimed to study the rel

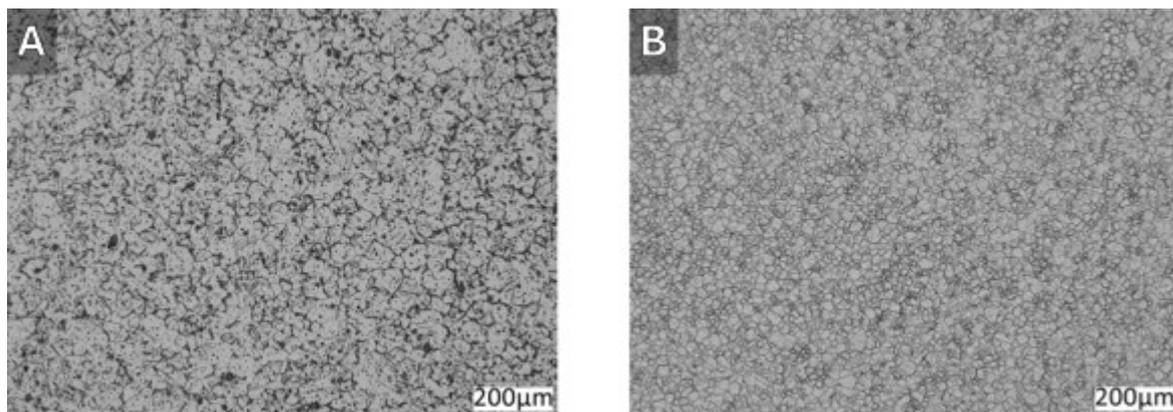
Microstructural investigation and defects characterization The MEX-fabricated specimens showed a microstructure with equiaxed austenitic grains and several precipitates, as visible in Figure 1A. Moreover, typical macro-defects of MEX technology were also visible under digital optical microscope. Hot worked specimens were characterized as well by austenitic equiaxed grains with characteristic twins as shown in Fig. 1B, with finer grains with respect to MEX specimens.

**Fig.1** - Metallografia x200 della lega 625 ottenuta per MEX A) e HW B). / Metallography of alloy 625 processed by MEX A) and HW B).

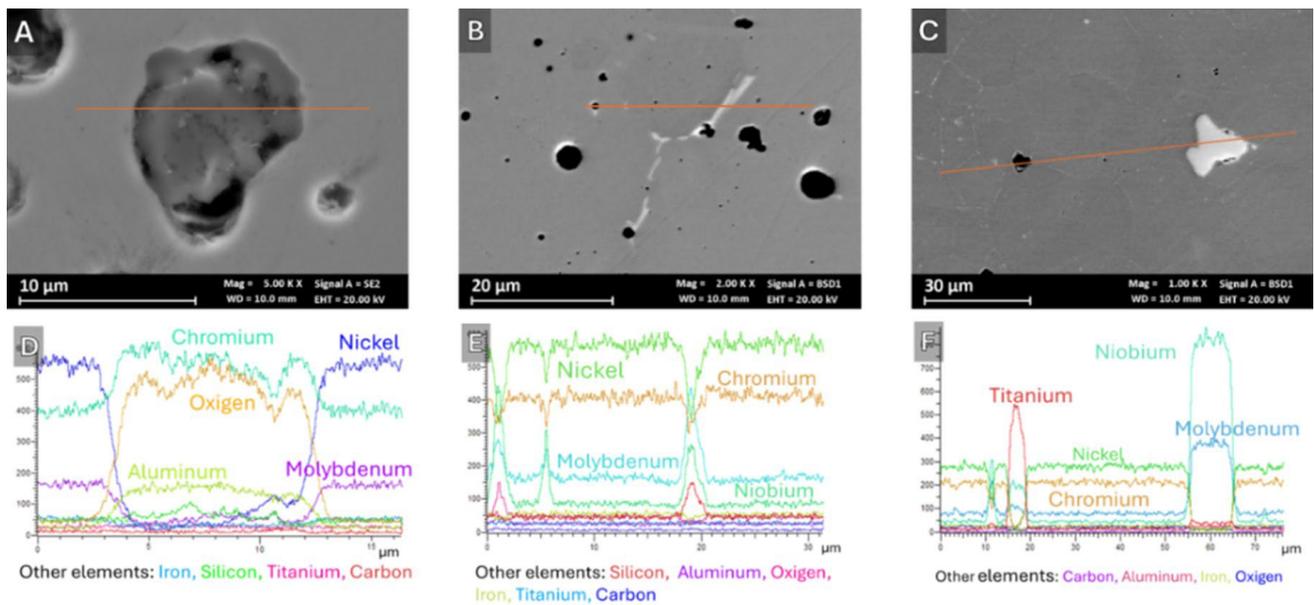
EDS analysis detected carbides of Ni e Mo in alloy 625 manufactured via MEX, as shown in Fig. 2A. It is focal to specify that such carbides are homogeneously arranged and in block shapes in the core, while they are elongated and primarily arranged along the grain boundaries in the contour. Furthermore, inclusions of oxides rich in Al, Si, and Cr and surrounded by a secondary phase were discovered (Fig. 2B). In literature, it has been proposed that oxides and carbides form during debinding and

sintering by the capture of impurities [14], [15]. The reference HW material is characterised by the presence of carbides, both in blocks and elongated along the grain boundary forming semi-continuous chains, as visible in Fig. C. Second phases rich of titanium were also detected in HW specimens.

**Fig.2** - Analisi EDS di provini MEX A), B), D), E) e HW C), F) / EDS Analysis of MEX A), B), D), E) and HW C), F)

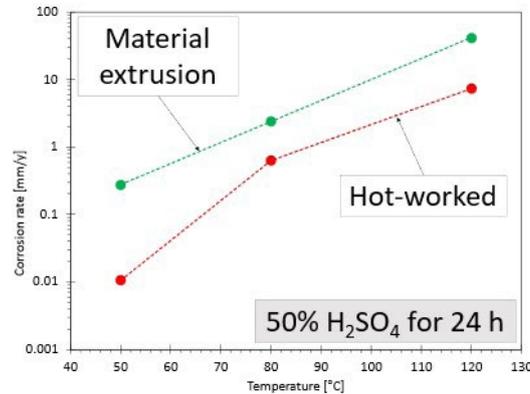
The weight losses in 50% sulfuric acid solution showed an exponential trend depending on the temperature of the solution, as seen in Fig. 3. At higher temperatures, there

is an increase of the movement of ions and reduction of oxygen concentration all contributing to higher corrosion rates [16], [17].

**Fig.3** - Velocità di corrosione della lega 625 in 50% H<sub>2</sub>SO<sub>4</sub> in funzione della temperatura della soluzione / Corrosion rates vs solution temperature of alloy 625 in 50% H<sub>2</sub>SO<sub>4</sub>

The corrosion rate of alloy 625 HW is comparable with the values already reported in the literature [18], [19]. Conversely, MEX exhibited corrosion rates an order of magnitude higher than those of the alloy obtained through traditional technology. Furthermore, MEX showed high corrosion rates already at 50 °C, while HW displayed significantly lower corrosion rates at that temperature. Digital optical microscope analysis of the exposed surfaces proved that the corrosion attacks morphology

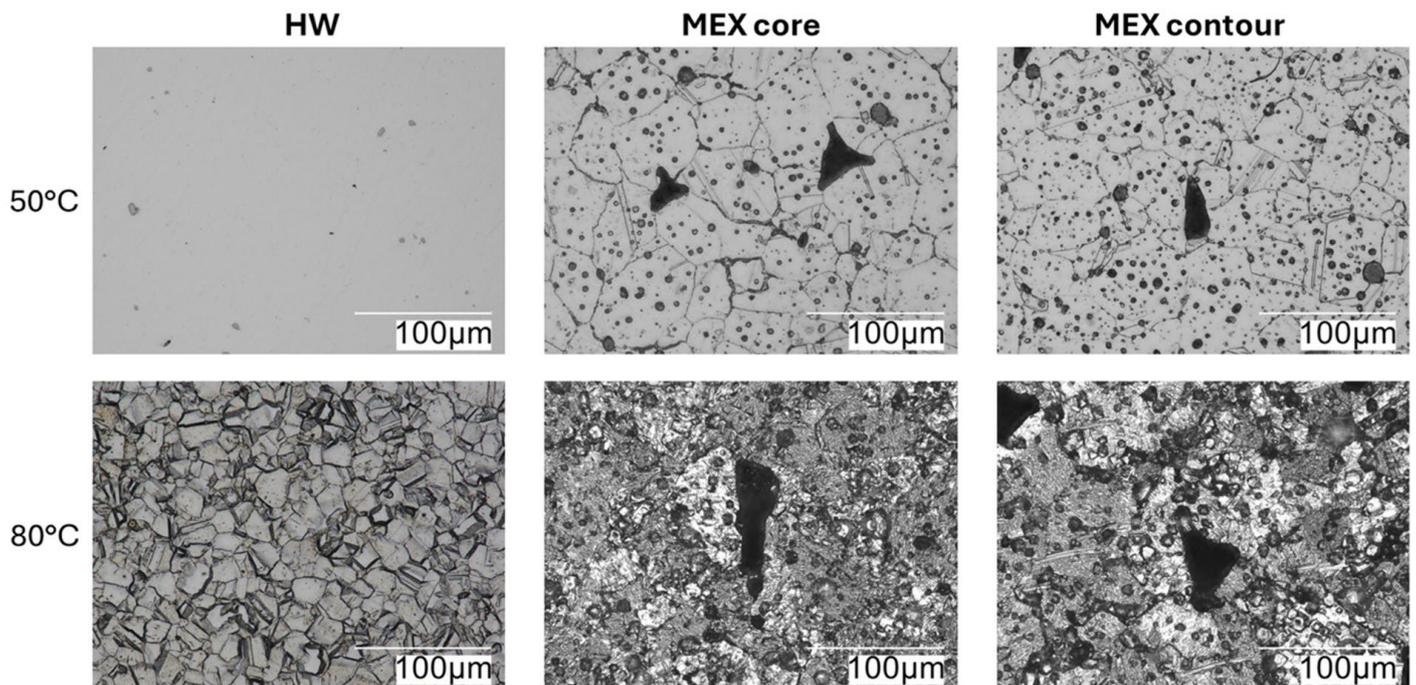
in both MEX and HW preferentially follows the grain boundaries, as shown in Fig. 4.

**Fig. 4** - Superfici della lega 625 dopo le prove di immersione in  $H_2SO_4$  a 50°C e 80°C – Surface of alloy 625 after immersion test in  $H_2SO_4$  at 50°C and 80°C.

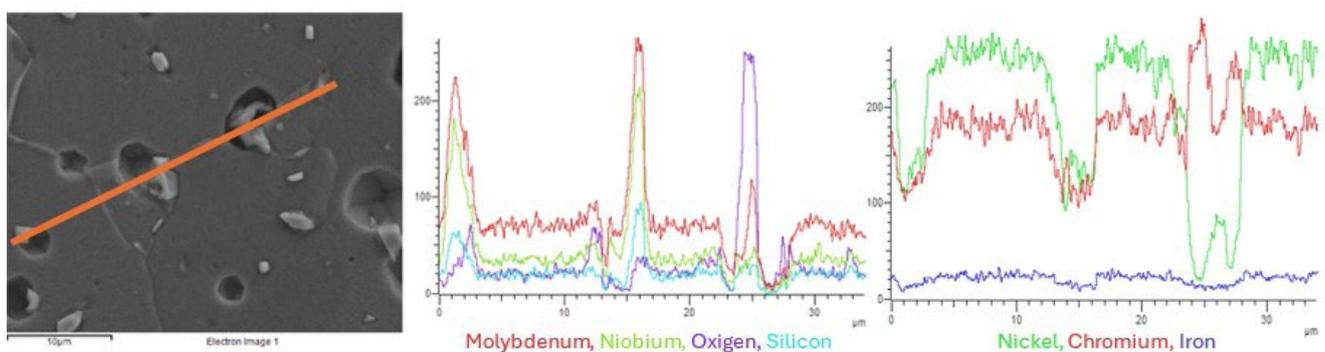
EDS of alloy 625 after the immersion test demonstrated that the interface between carbides/Ni-grain and oxides/Ni-grain is the predominant site where the corrosion occurs (Fig. 5). Therefore, it is plausible that the intergranular corrosion behaviour of Alloy 625 in both HW

and MEX is highly affected by the presence of carbides with adjacent Ni and Cr depleted zones, distributed along the grain boundaries [20].

**Fig. 5** - Analisi EDS di un provino MEX a seguito della prova di immersione in  $H_2SO_4$  a 50°C - EDS Analysis of MEX specimen after immersion test in  $H_2SO_4$  at 50°C.

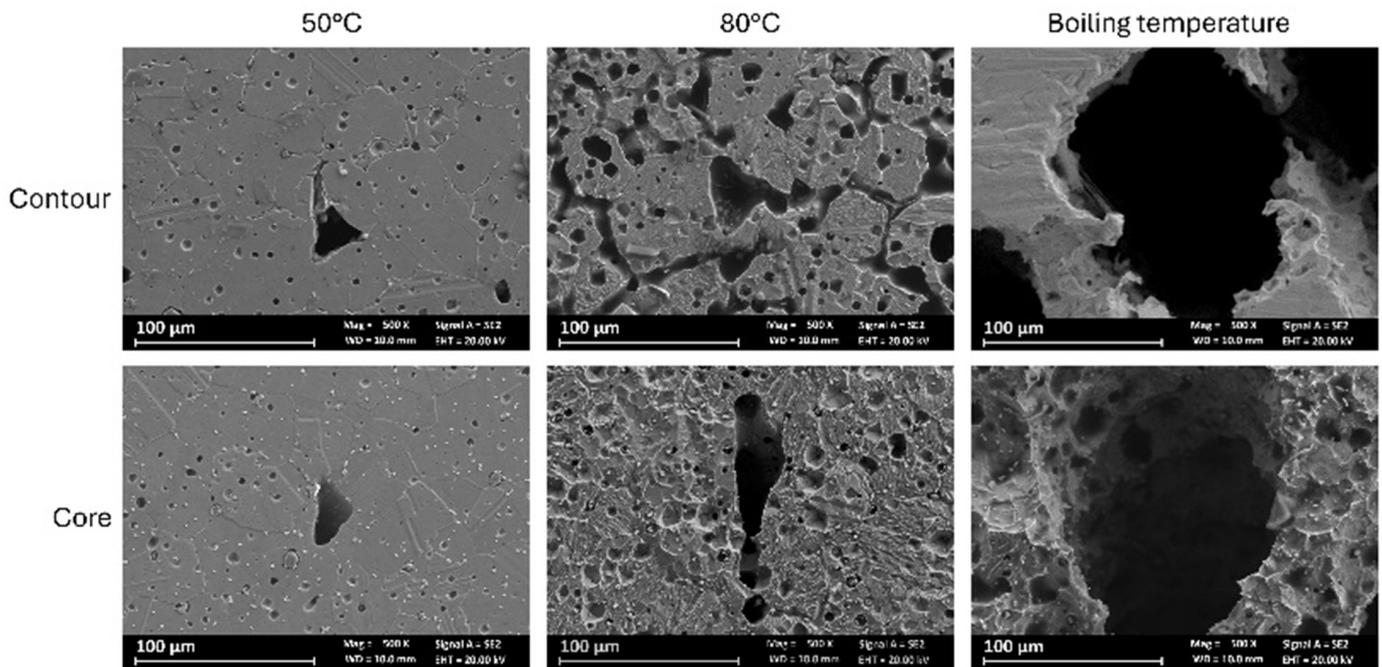
During immersion test, macro-defects of alloy 625 MEX increased in size because of severe corrosion occurring. The defect size increased greatly with the aggressiveness of the solution, as visible in Fig. 6. The enlargement of defects leads to an expansion of surface exposed to

the corrosive environment, contributing to the higher corrosion rates observed in MEX specimens if compared to the HW benchmark.

**Fig. 6** - Macro-difetti dei provini MEX post immersione in H<sub>2</sub>SO<sub>4</sub> a differenti temperature / MEX macro-defects after immersion test in H<sub>2</sub>SO<sub>4</sub> at different temperature.
